TECHNICAL INSPECTION REPORT

U.S.S. SALT LAKE CITY (CA25)

TEST ABLE

OPERATION CROSSROADS

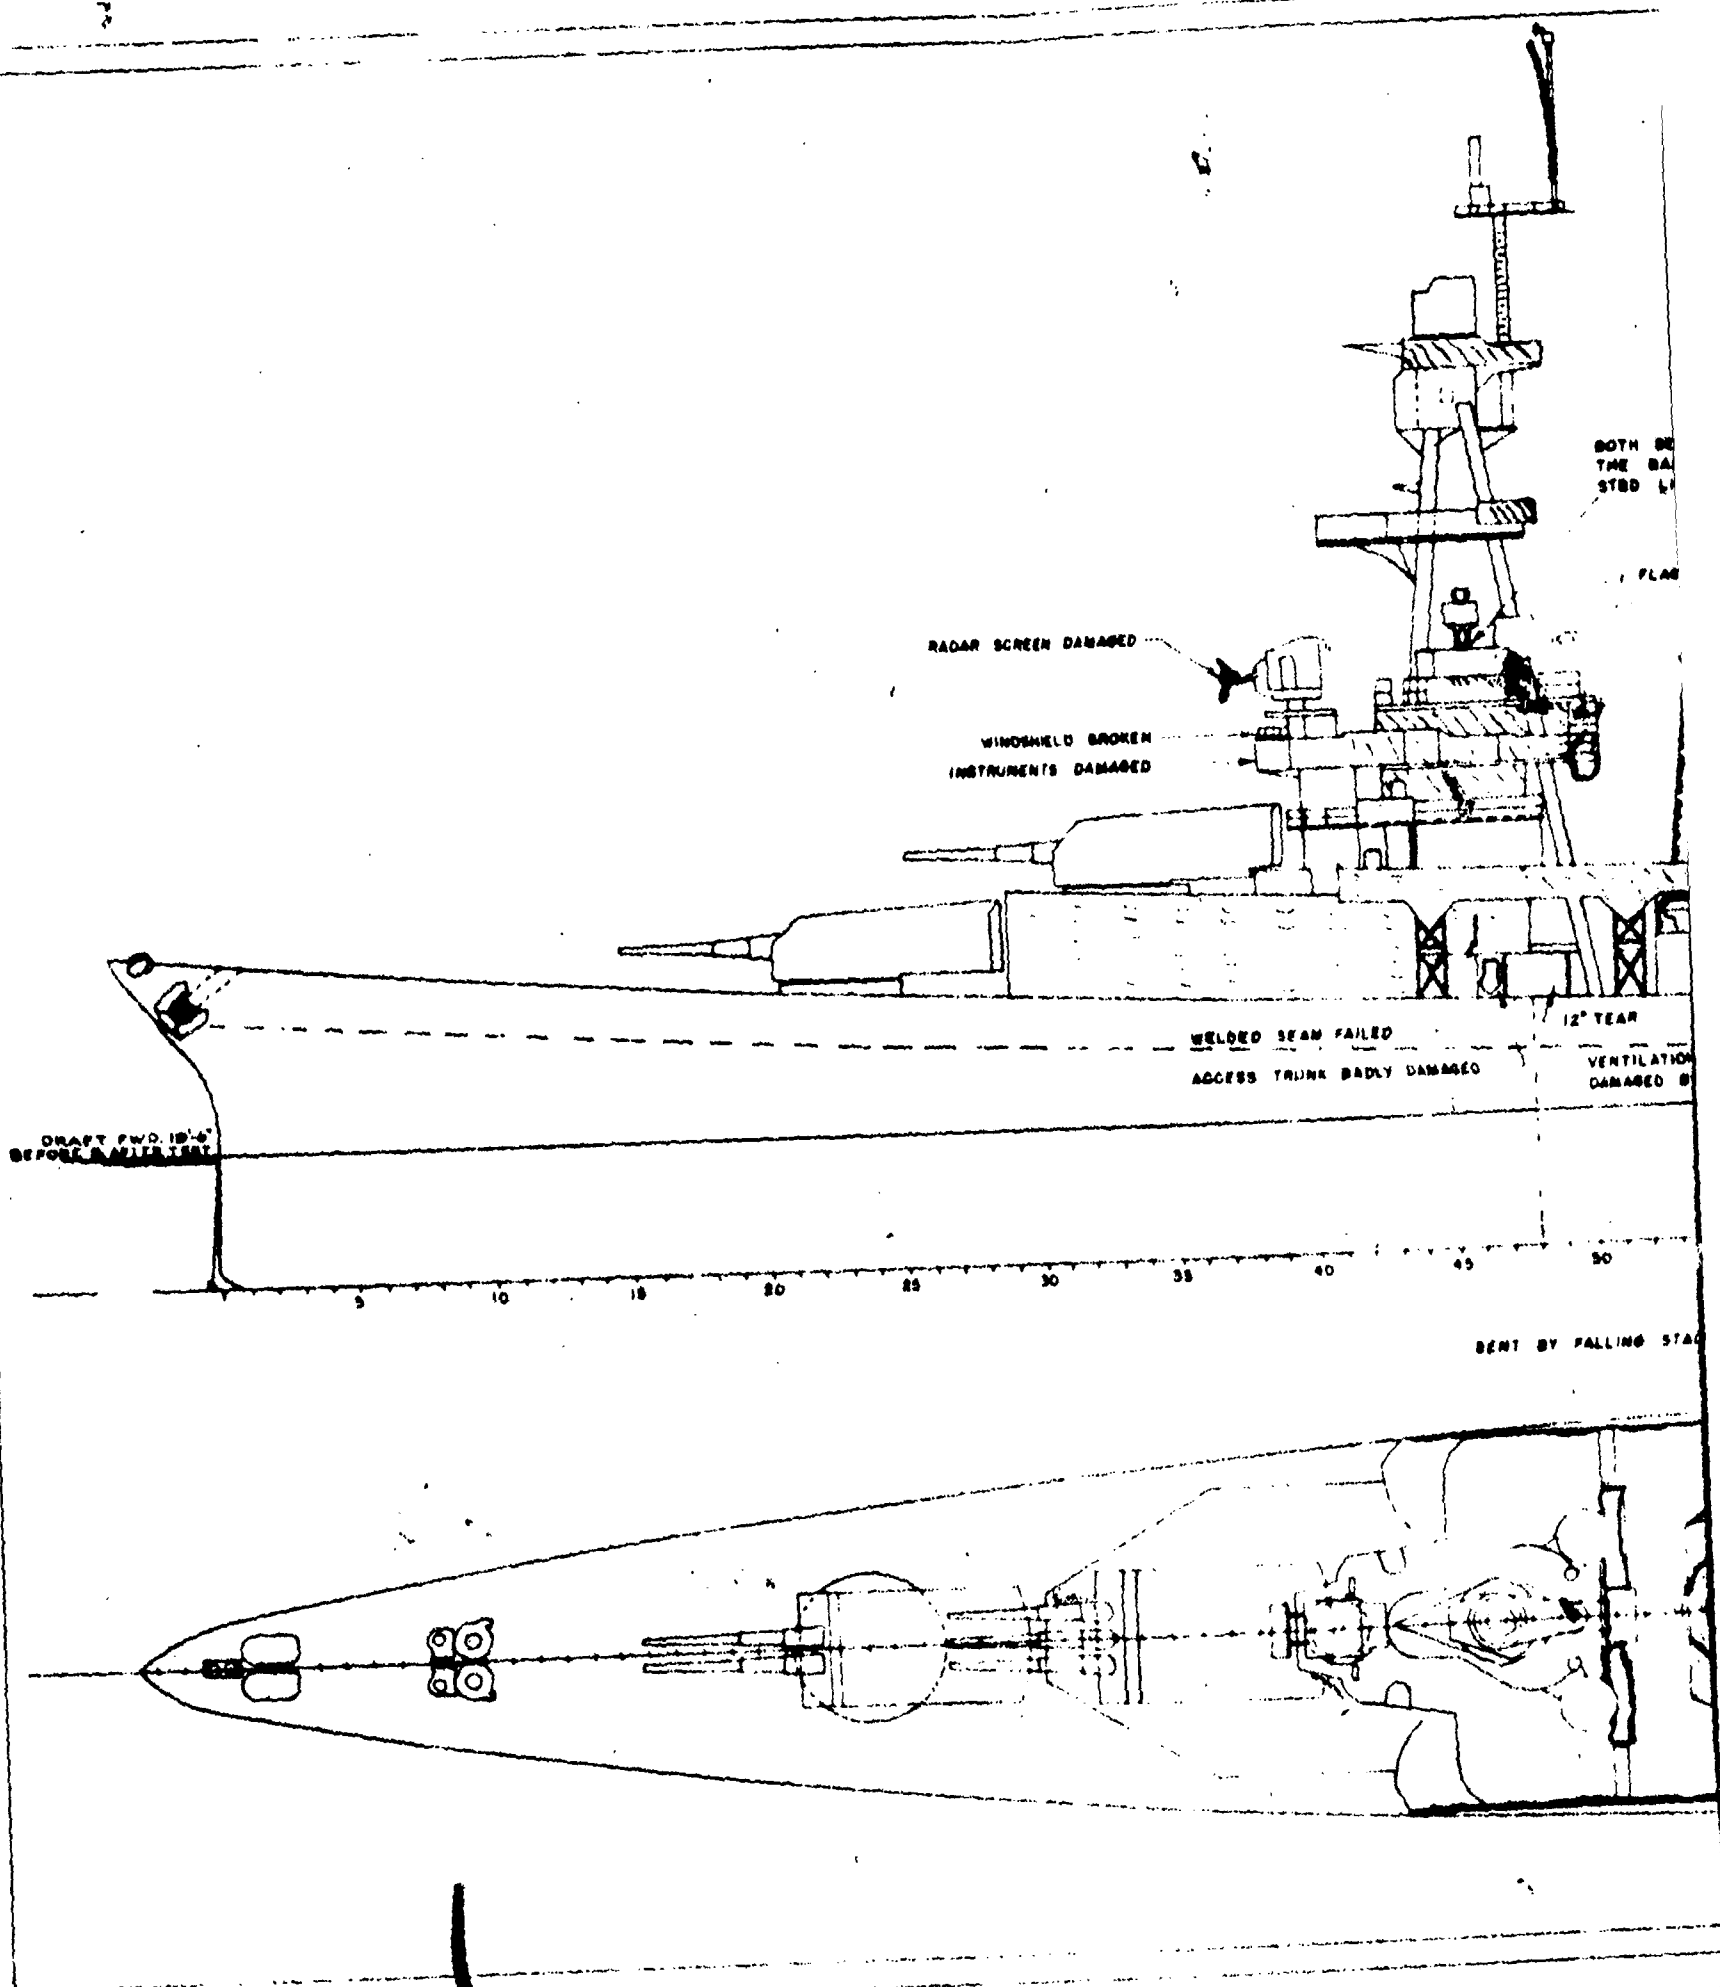
BOTH SEARCHLIGHTS BROKEN AT
THE BASE RING
STBD LIGHT THROWN ONTO NAV BRIDGE

BENT TO STBD AND FORD
APPROXIMATELY 25°

DECK TORN AT EXHAUST VENT

STACK TORN AWAY ABOVE DECK

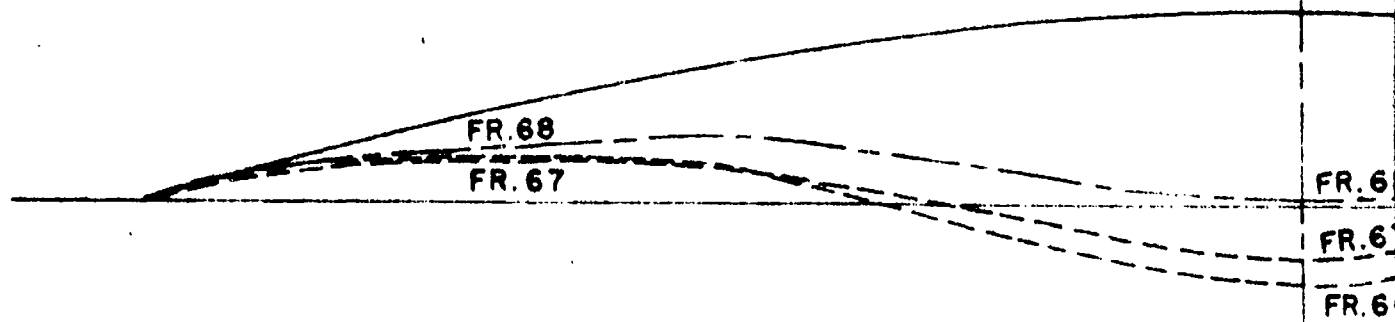
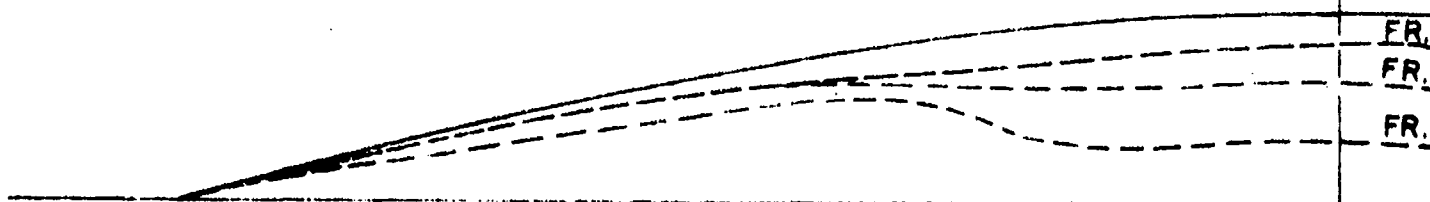
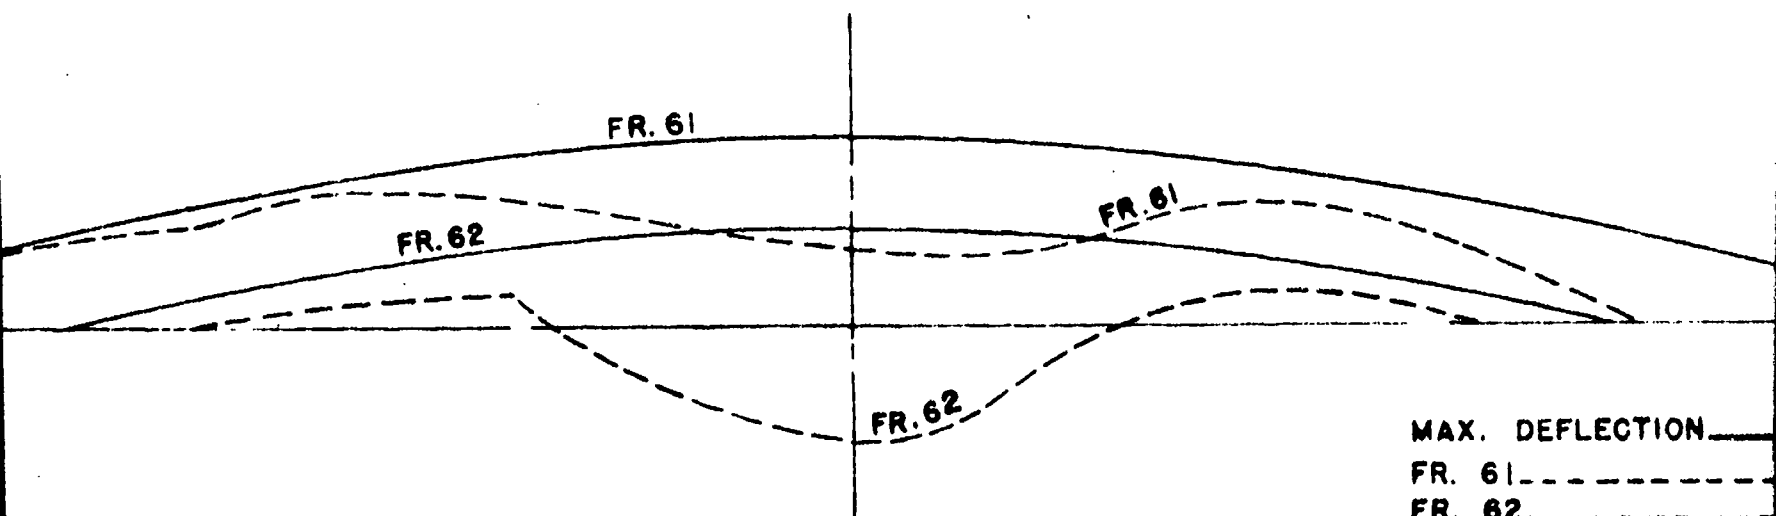
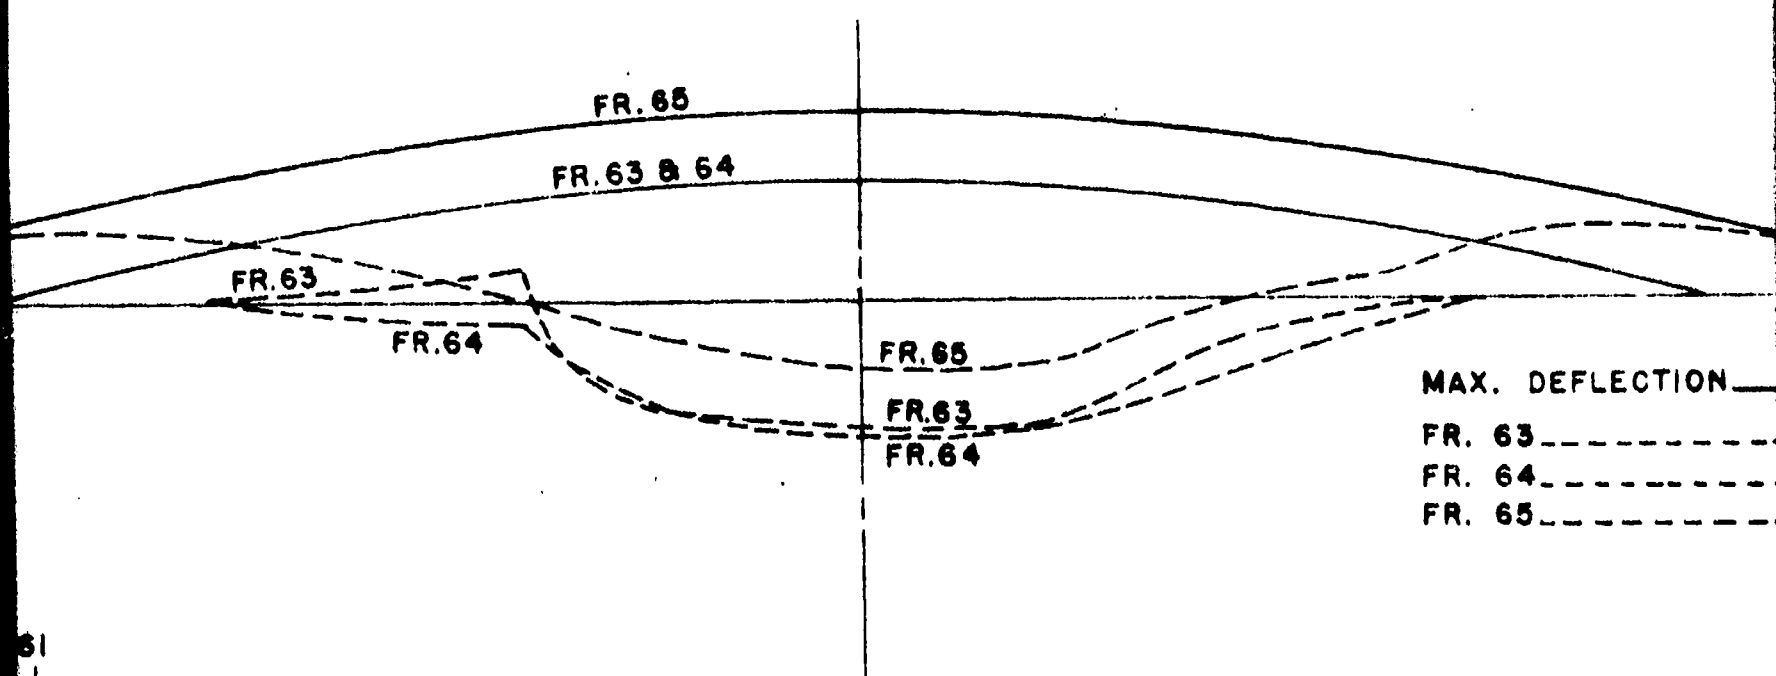
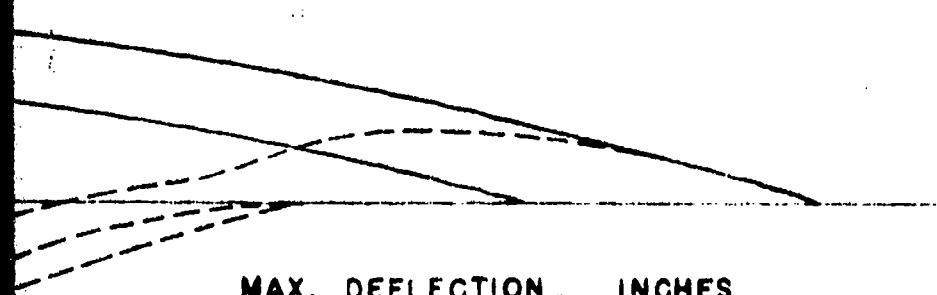
DEFLECTION OF MAIN
 DECK, FRAMES 61--71
 TEST ABLE

The main deck has sustained a major deflection between bulkheads 61 and 71 1/2 with resultant buckling of stanchions below. There are also areas of minor dishing aft. There is no hull damage below the second deck, except for a leak in innerbottom tank C-909-F.

MAX. DEFLECTION _____ INCHES

FR. 66 ----- 16 1/4

FR. 67 ----- 14 1/2

FR. 68 ----- 11

FR. 69 ----- 7 1/2

FR. 70 ----- 4

FR. 71 ----- 1 3/4

MAX. DEFLECTION _____ INCHES
 FR. 61 _____ 6 7/8
 FR. 62 _____ 12 1/2

MAX. DEFLECTION _____ INCHES
 FR. 63 _____ 14 3/4
 FR. 64 _____ 15 1/4
 FR. 65 _____ 15 3/8
